EVRF Radiofrequency CR45i Histology

By Doctor Atilla Szabo
Budapest, hungary

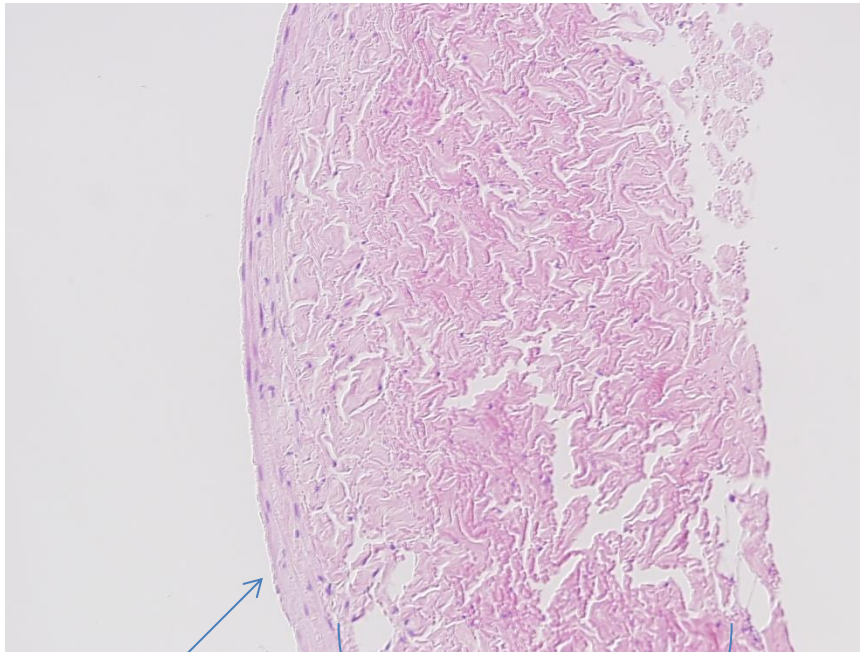
Vein wall before and after EVRF treatment – HE stain, 200x

Normal endothel

Intact media layer

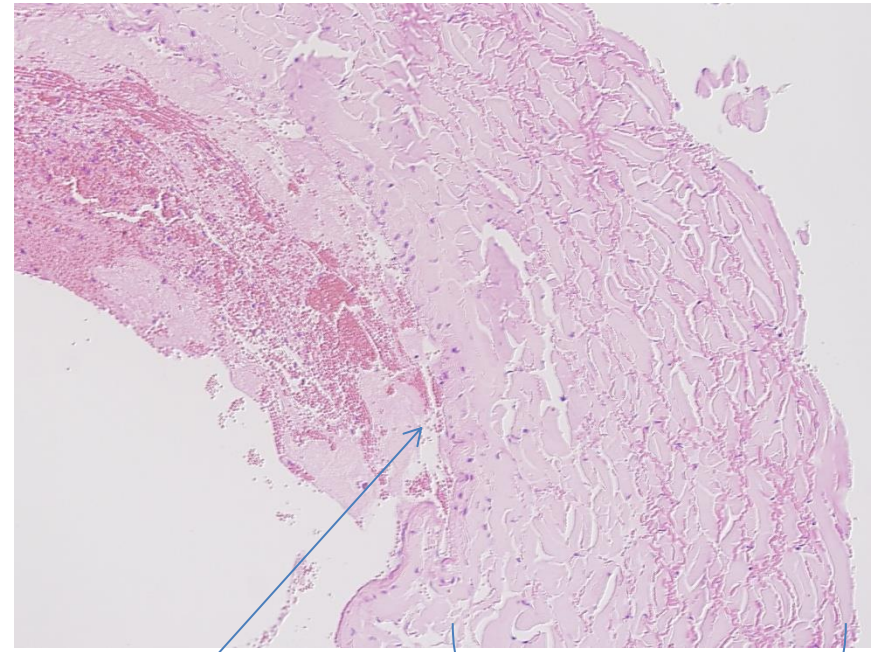
Desintegrated endothel cells,
thrombus formation

Desintegrated, blown up muscle cells and
elastic fibers due to thermal damage

- Clear difference between untreated and treated veins
 - Treated veins showed the desirable desintegration of the endothelial layer
 - Adherent thrombus formed in the lumen after treatment
 - Damage to muscle cells and elastic fibres due to thermal damage caused by RF with the CR45i catheter
-

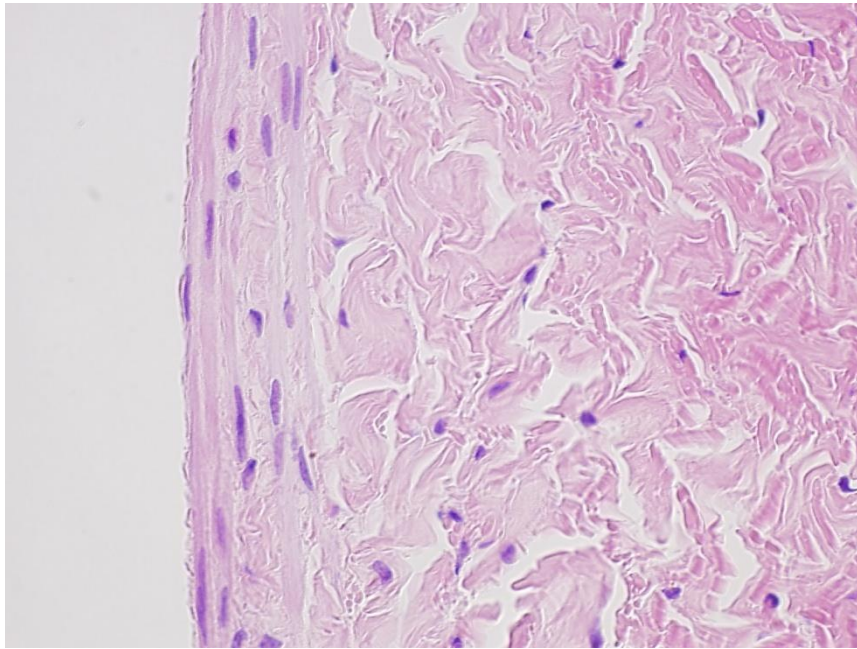
Vein wall before and after EVRF treatment

– HE stain, 600x

Normal endothel

Intact media layer

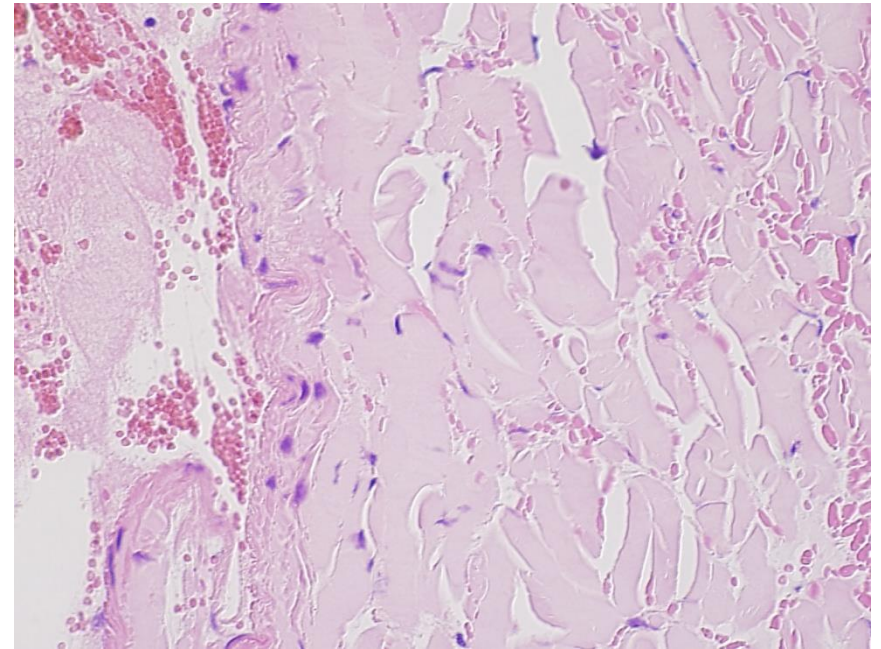
Desintegrated endothel cells

Desintegrated, blown up muscle cells and elastic fibers due to thermal damage
